**PRE-CONSTRUCTION HAZARDOUS MATERIAL SURVEY
for ASBESTOS CONTAINING MATERIAL and LEAD BASED PAINT**

**CHABOT COLLEGE
BUILDING 3700
25555 HESPERIAN BOULEVARD
HAYWARD, CALIFORNIA**

July 3, 2025

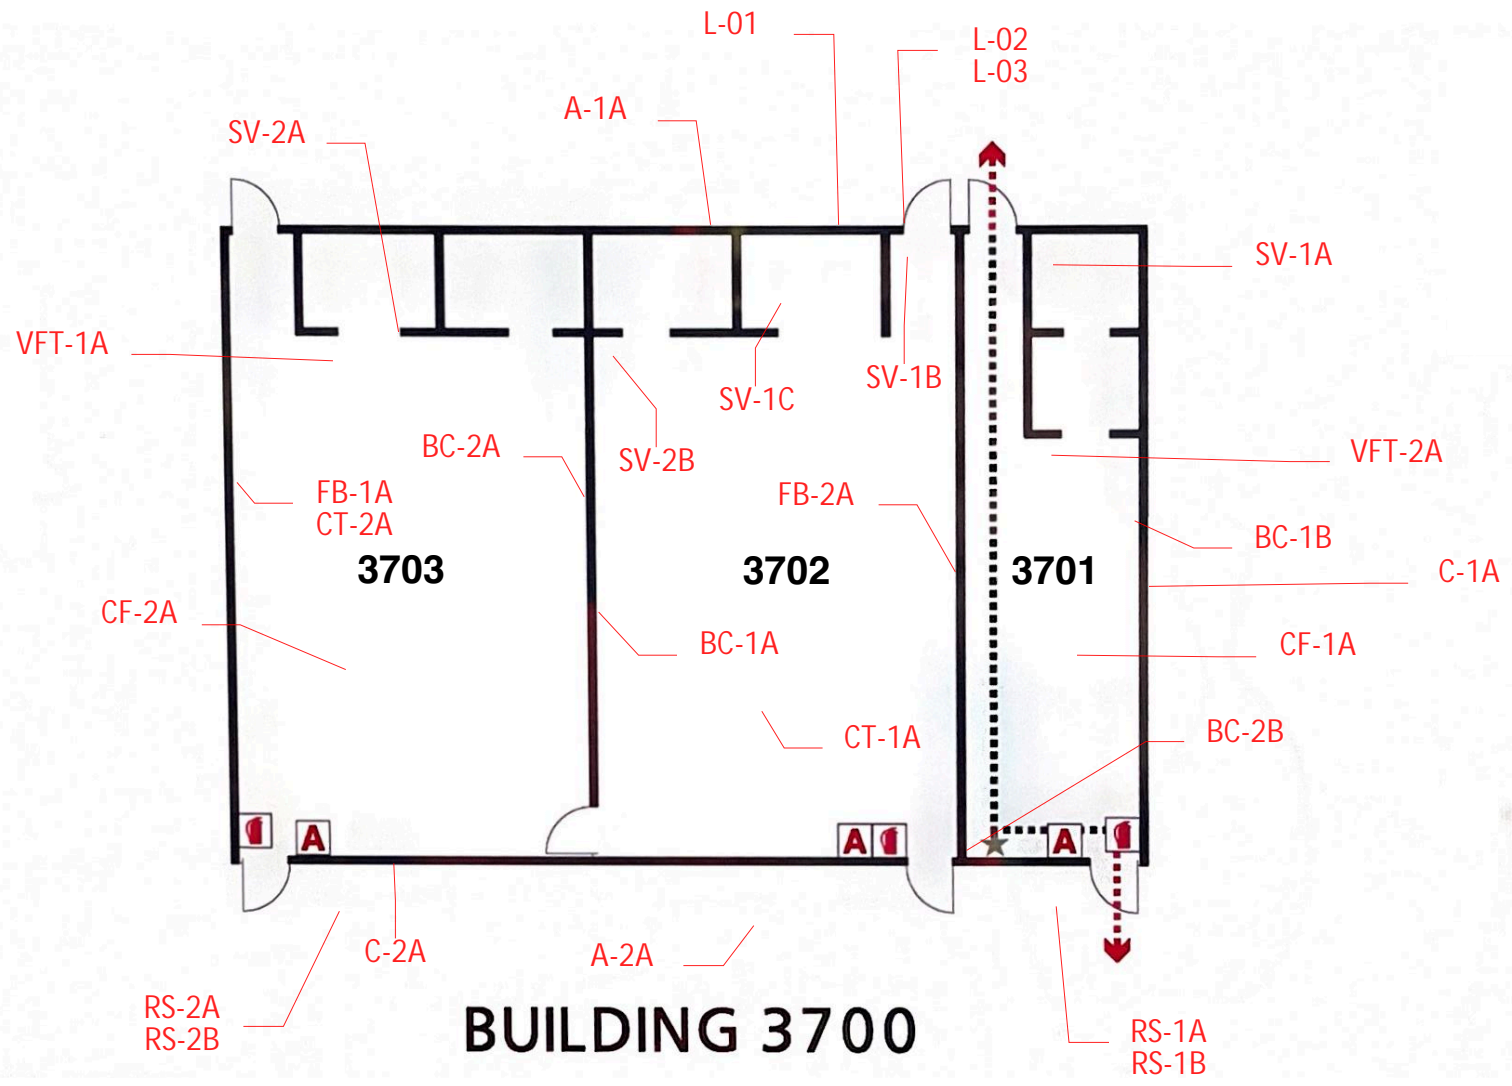
APPENDIX D
(SAMPLE LOCATION MAP)

During the inspection 25 bulk samples of suspect asbestos containing material were collected. The Sample Location Diagram contained in Appendix C identifies the area where the bulk asbestos samples were collected.
