January 15, 2008

Subject            Preservation and Transplanting Specifications  
                         Chabot College, Hayward

Subject            Transplanting Specifications  
                         Chabot College, Hayward

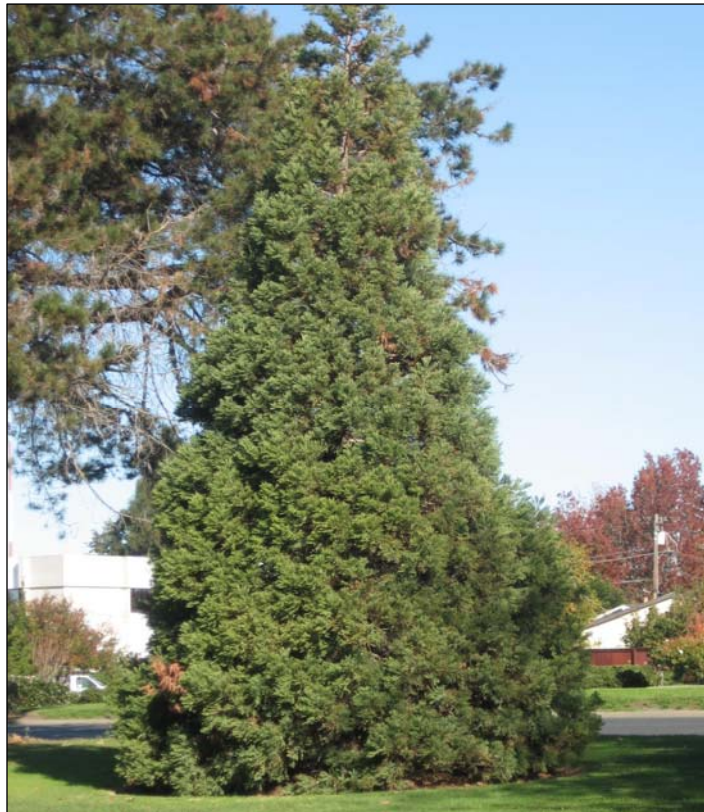
Monterey pine #182 was located in the same island but was in fair condition. Its fair condition was due to the presence of pine pitch canker (*Fusarium circinatum*), a fungal pathogen responsible for branch tip dieback and sap production along trunks and branches. Pine pitch canker can reduce vigor and resistance to other insects and diseases over time.

Giant sequoia #191 and dawn redwoods #192-194 were also located in a row along Hesperian Boulevard. These were all young trees in good to excellent condition. The Giant sequoia had a dense crown and branches to the ground (Photo 1). The three dawn redwoods were closely spaced, producing a one-sided crown in tree #192.

Photo 1: Giant sequoia #191 was a young tree in excellent condition. The crown was dense, with branches to the ground. Branch tip dieback from pine pitch canker can be seen on the Monterey pine in the background.

Three (3) trees, including Giant Sequoia #191 and dawn redwoods #192 and 194, are too close to the proposed changes (2', 4' and 5' from the back of curb, respectively). In order to preserve these trees, I would recommend that a minimum horizontal distance of 10' be provided between the face of the trunk and the back of the proposed curb.
