January 15, 2008

Subject            Preservation and Transplanting Specifications  
                         Chabot College, Hayward

Subject            Transplanting Specifications  
                         Chabot College, Hayward

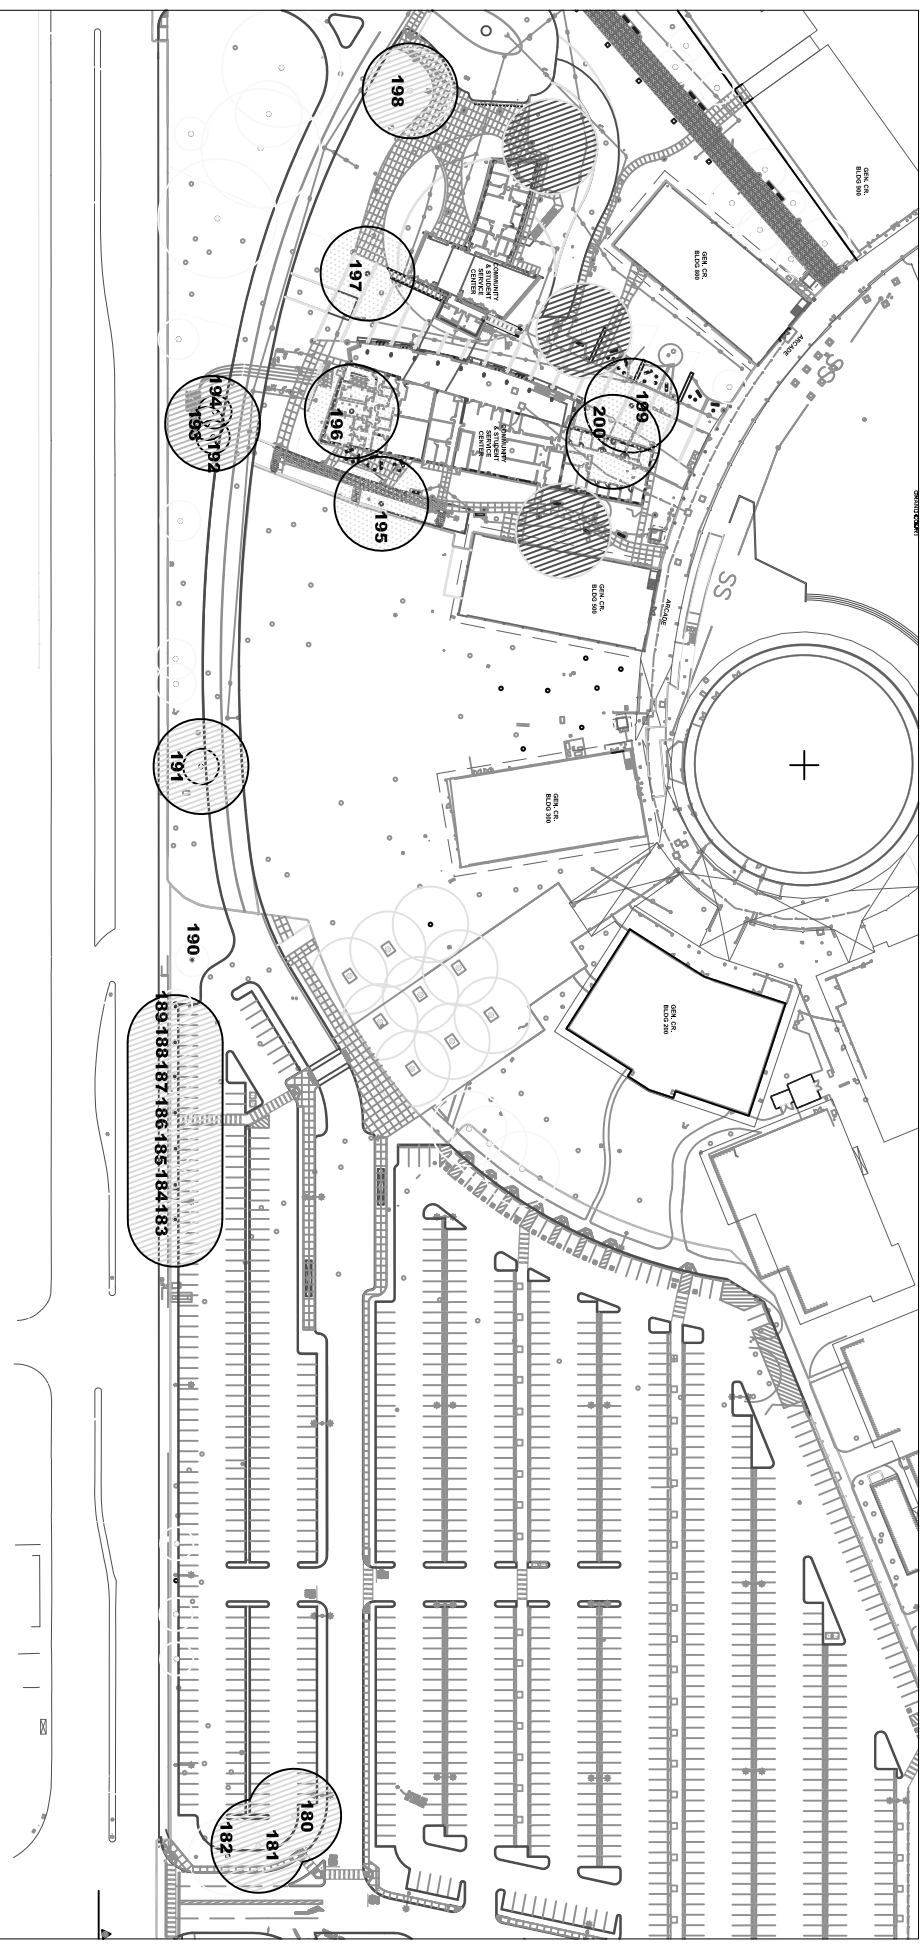
A total of 21 trees were surveyed within the area proposed for renovation. Descriptions of individual trees are found in the ***Tree Survey Form*** and locations are plotted on the ***Tree Survey Map*** (see attachments).
