CHABOT- LAS POSITAS COMMUNITY COLLEGE DISTRICT

Addendum No. 1 INVITATION FOR BID No. 08-10 Demolition of Buildings 400/600/700, Chabot College

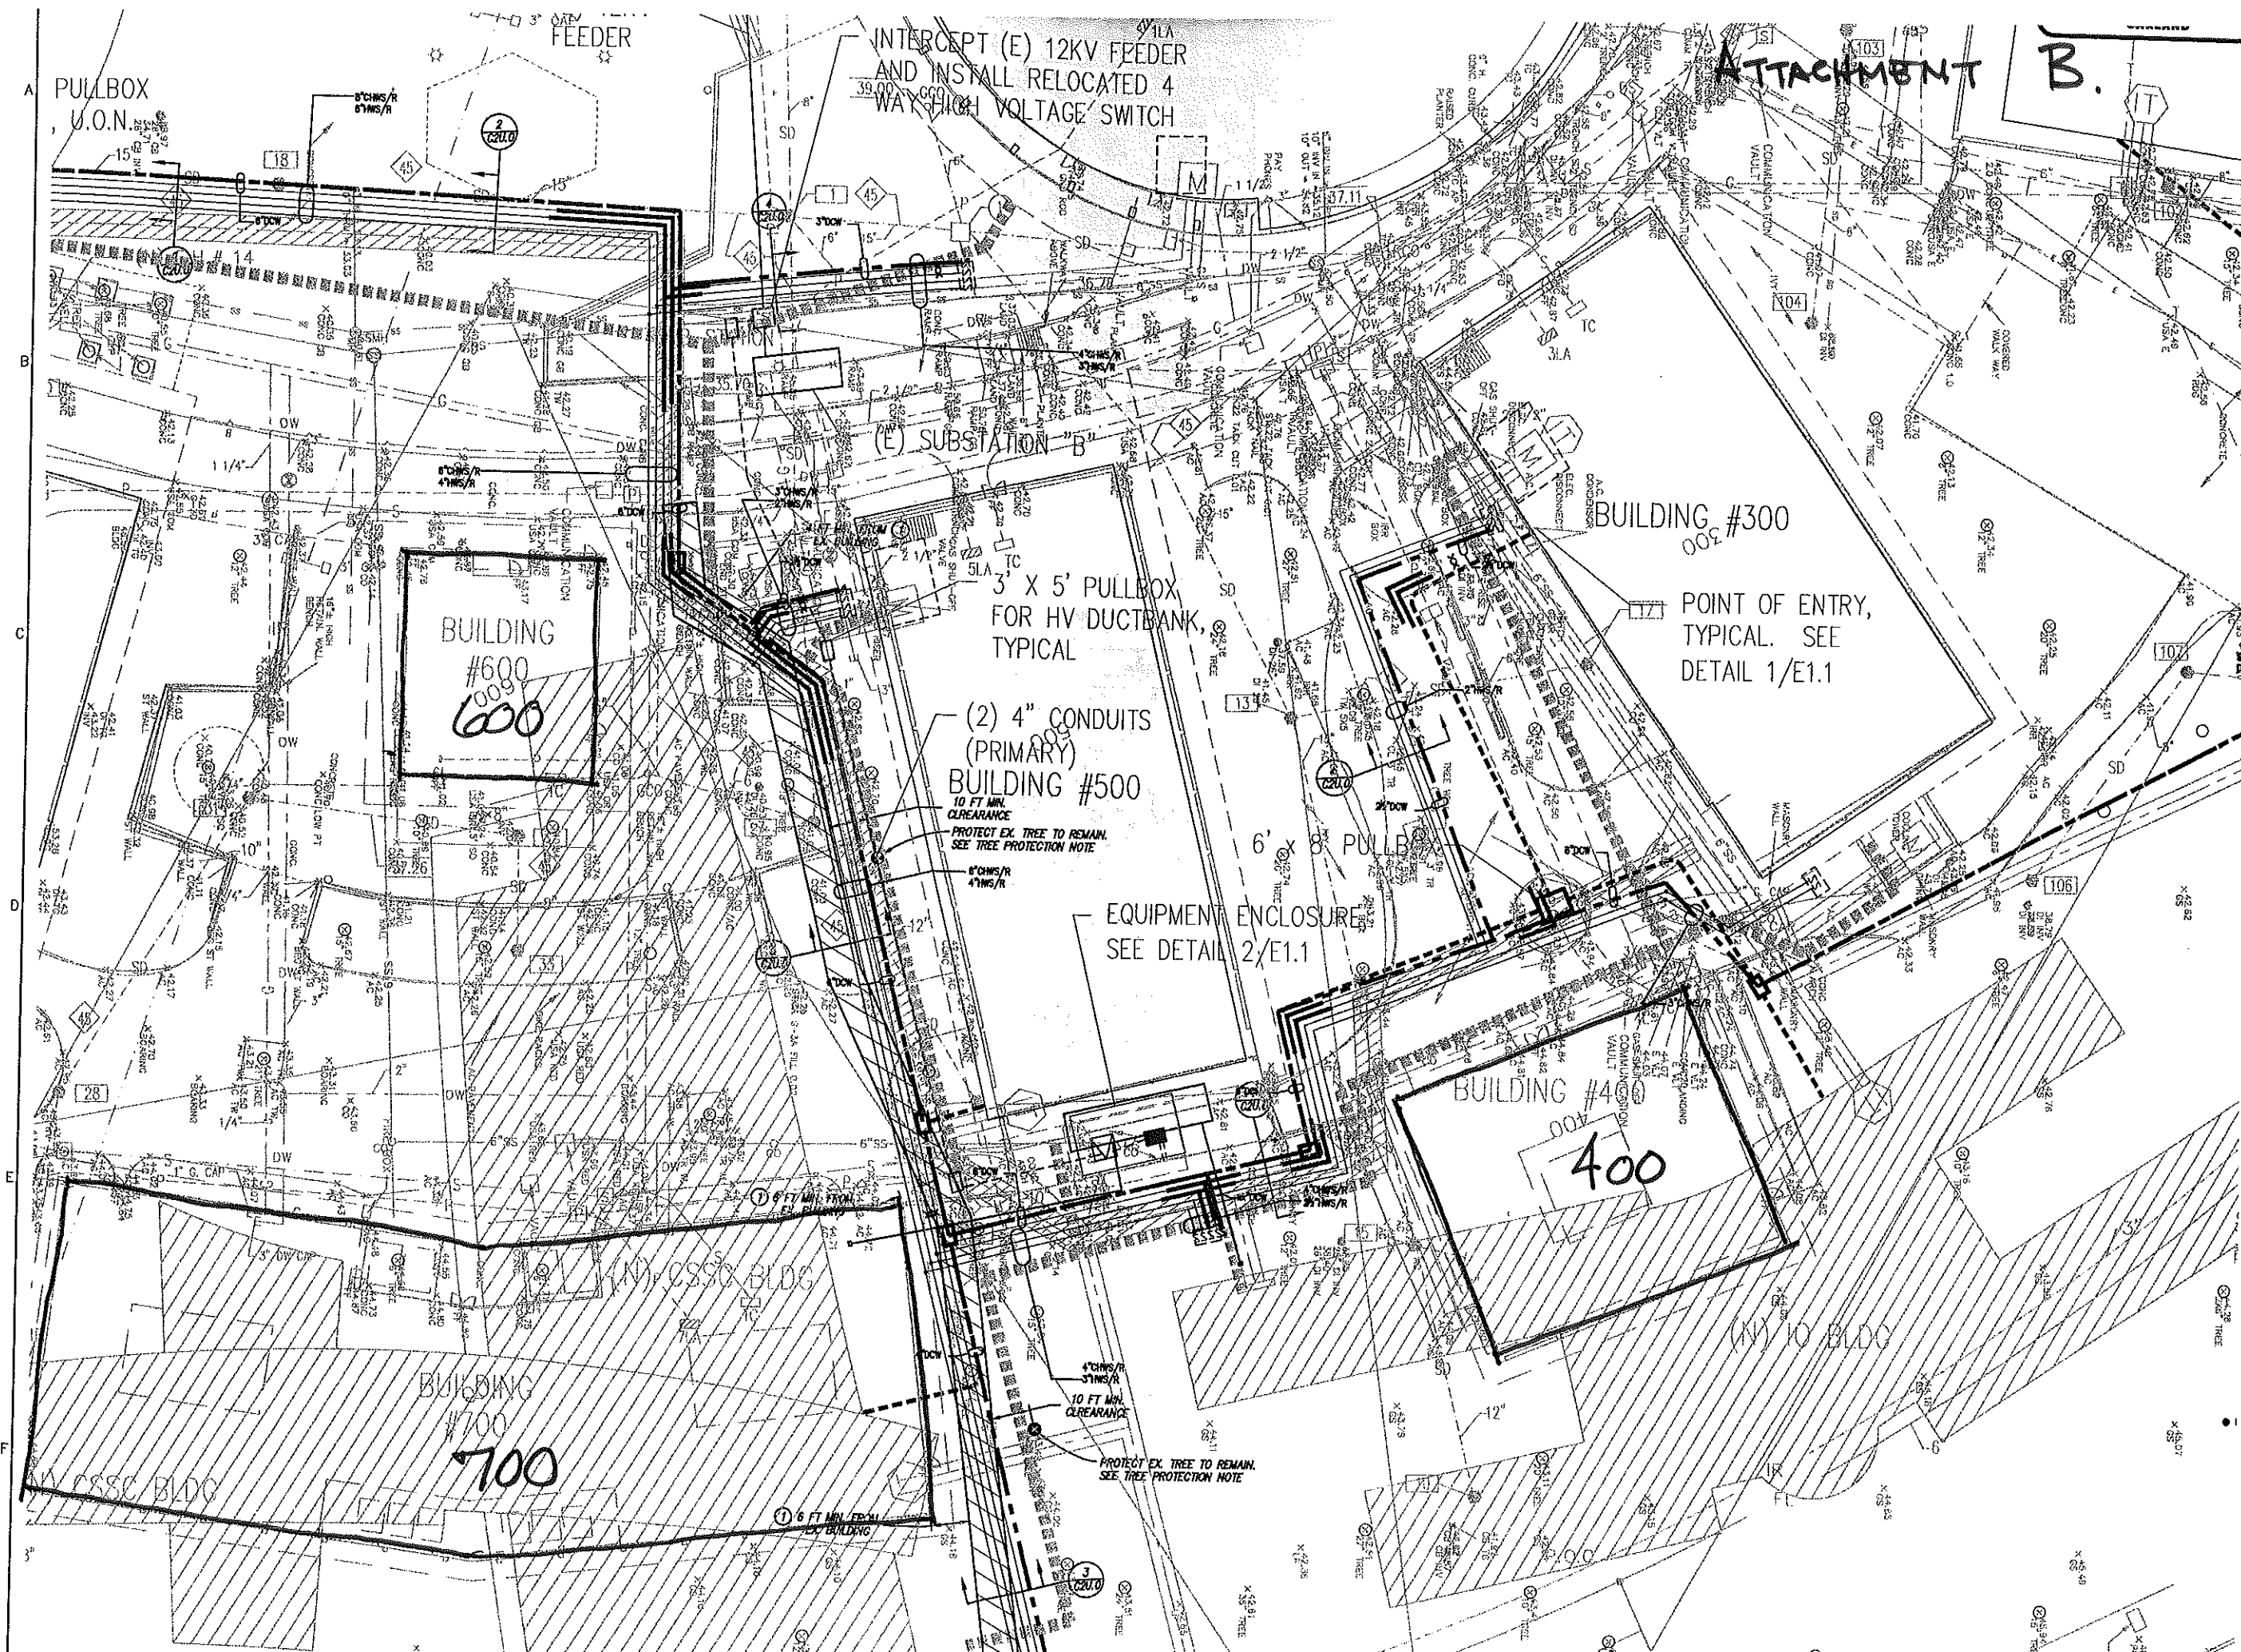
PULLBOX
U.O.N.

INTERCEPT (E) 12KV FEEDER
AND INSTALL RELOCATED 4
WAY 10KV VOLTAGE SWITCH
